Kwethluk Brownfield Case Study

Lessons in perseverance

John B. Carnahan
Brownfield Coordinator
DEC Reuse & Redevelopment Program

Alaska Conference on Environmental Management

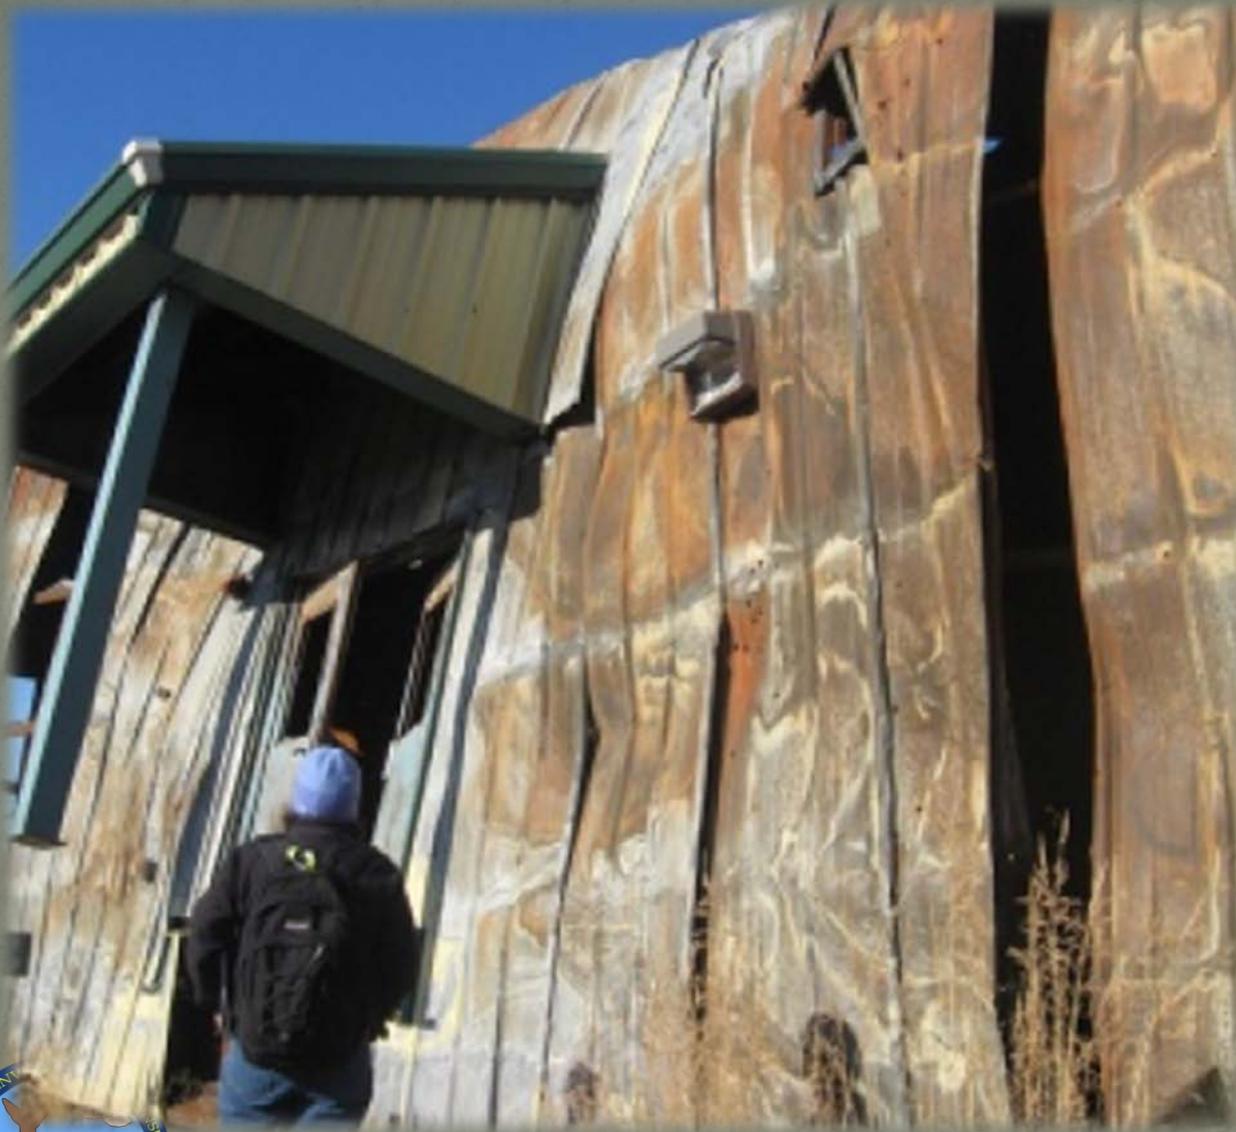
TBA - 2010

Inspecting the site

Five years after the
fire

Building still
standing

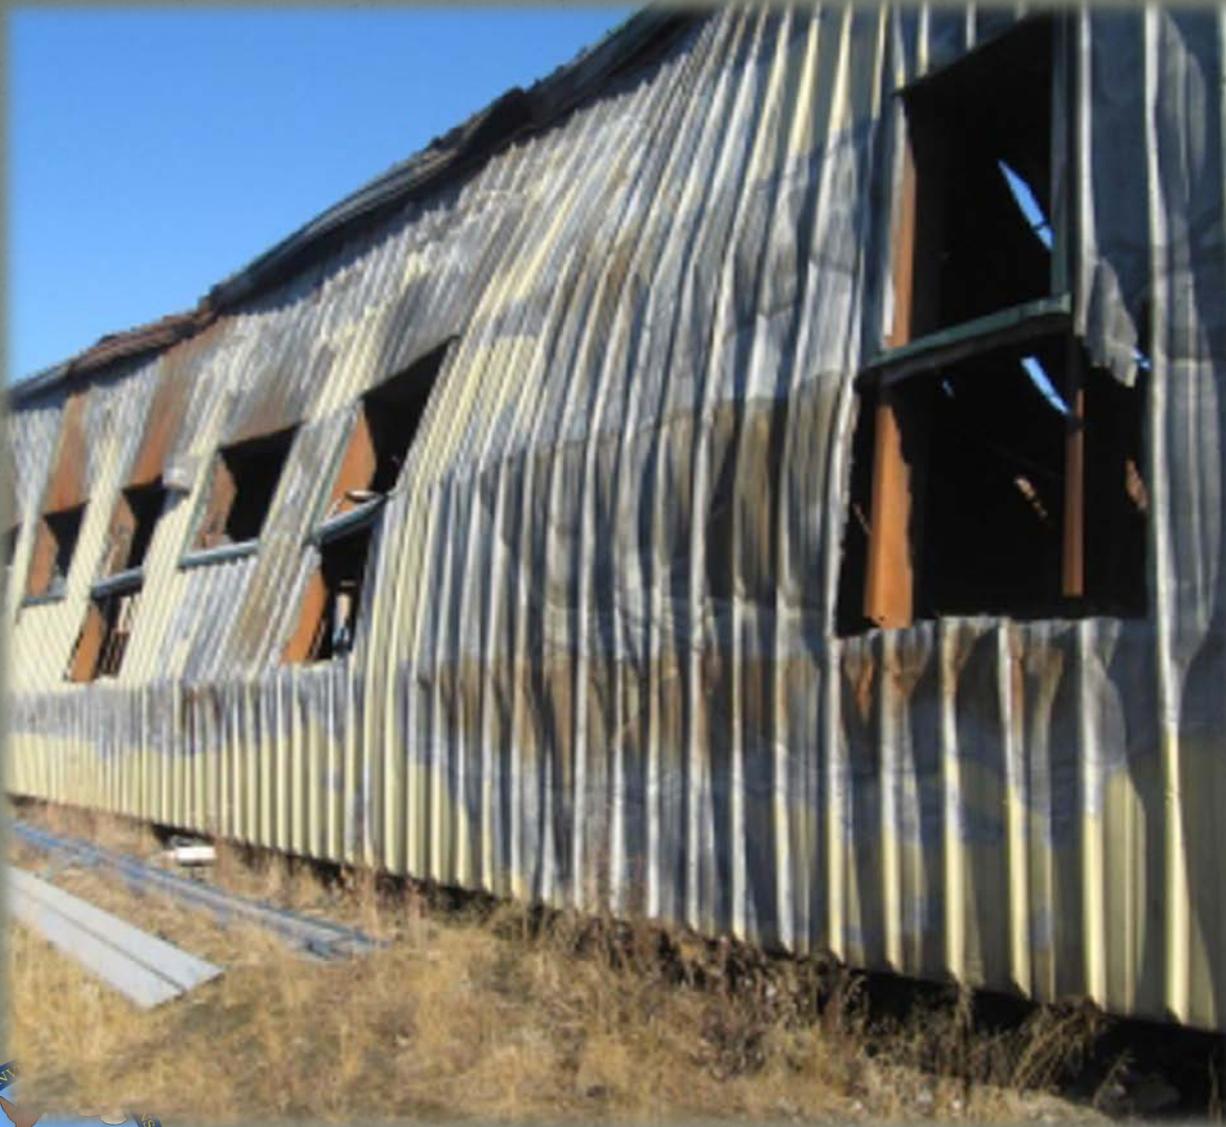
TBA - 2010

Building is constructed above grade on insulated pilings

Sides buckled in, but withstood snowfall

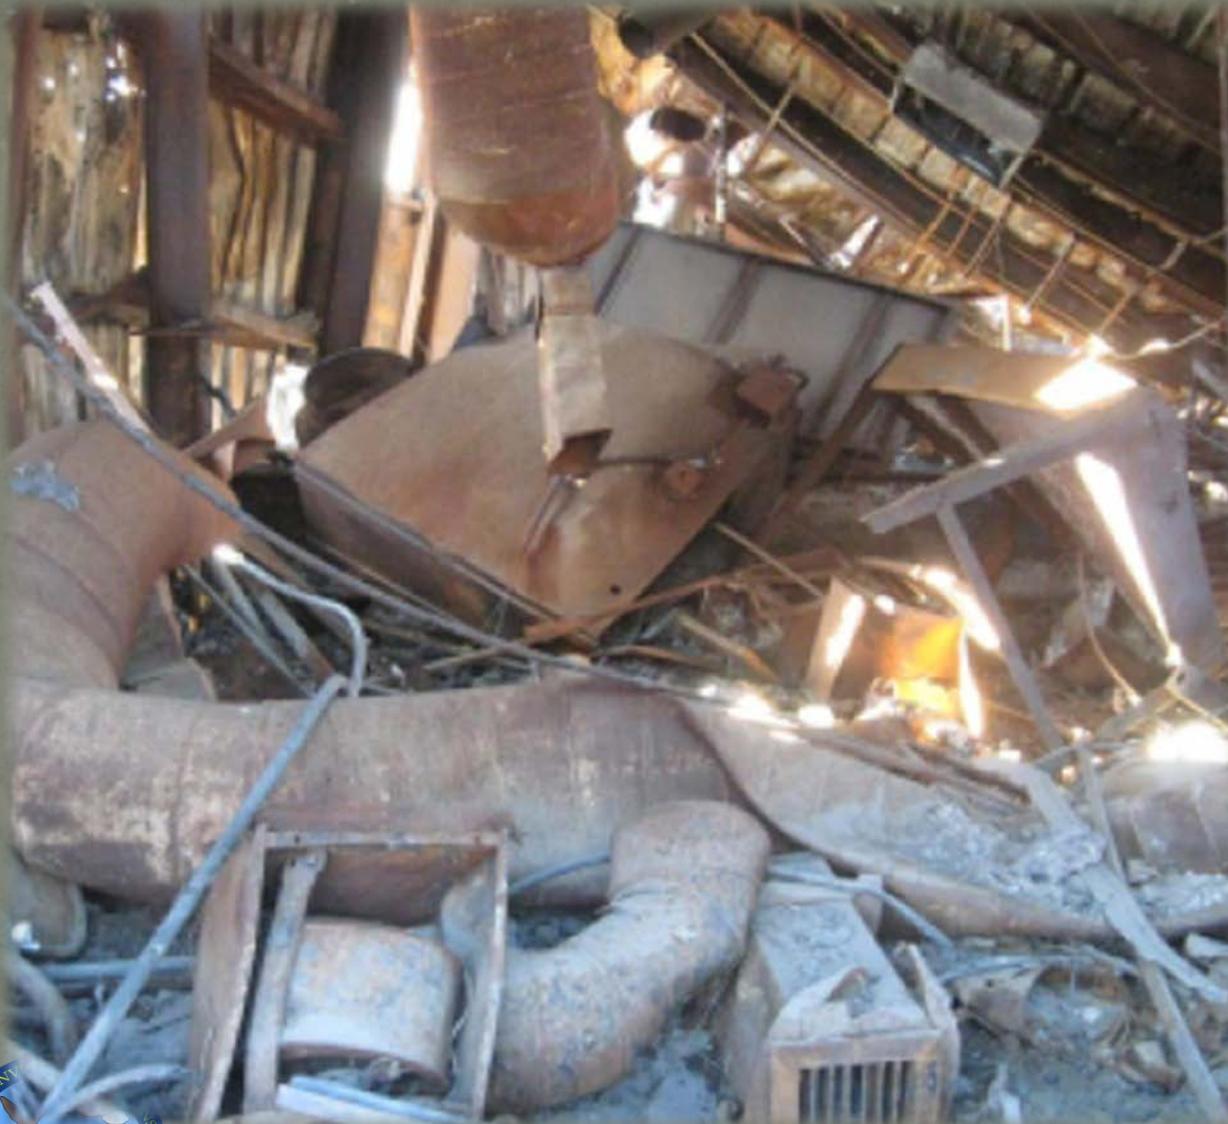
TBA - 2010

Plenty of debris
within structure

Concern over metals,
remnant burned
chemical residue –
dioxins

Physical hazards are
great

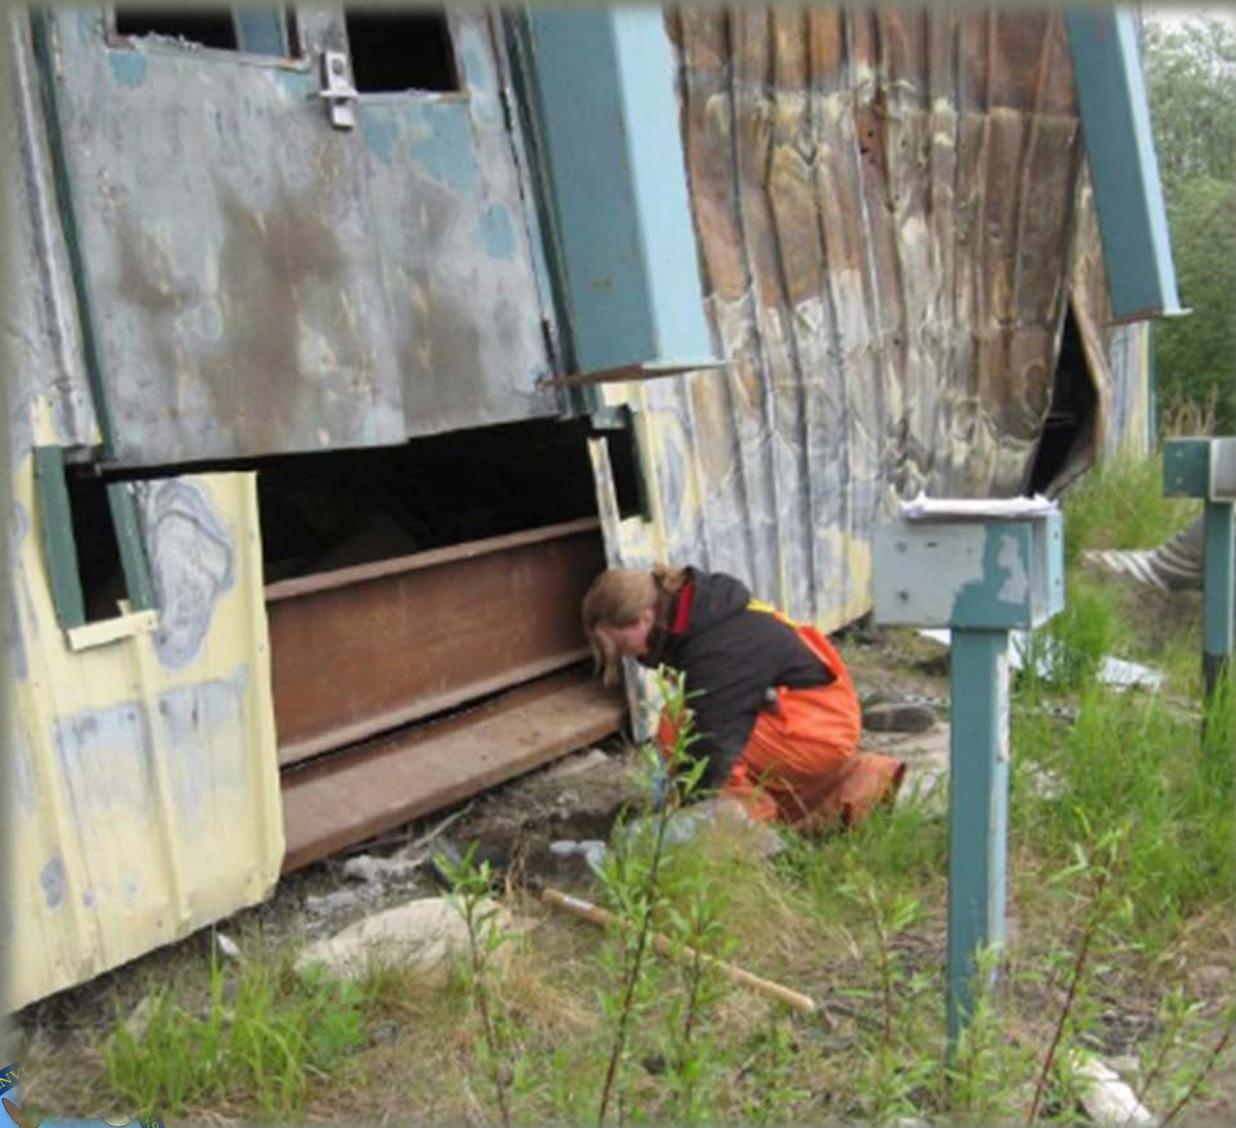
TBA - 2010

Sampling took place inside and outside the structure

Samples collected near old fuel tanks and where staining was present

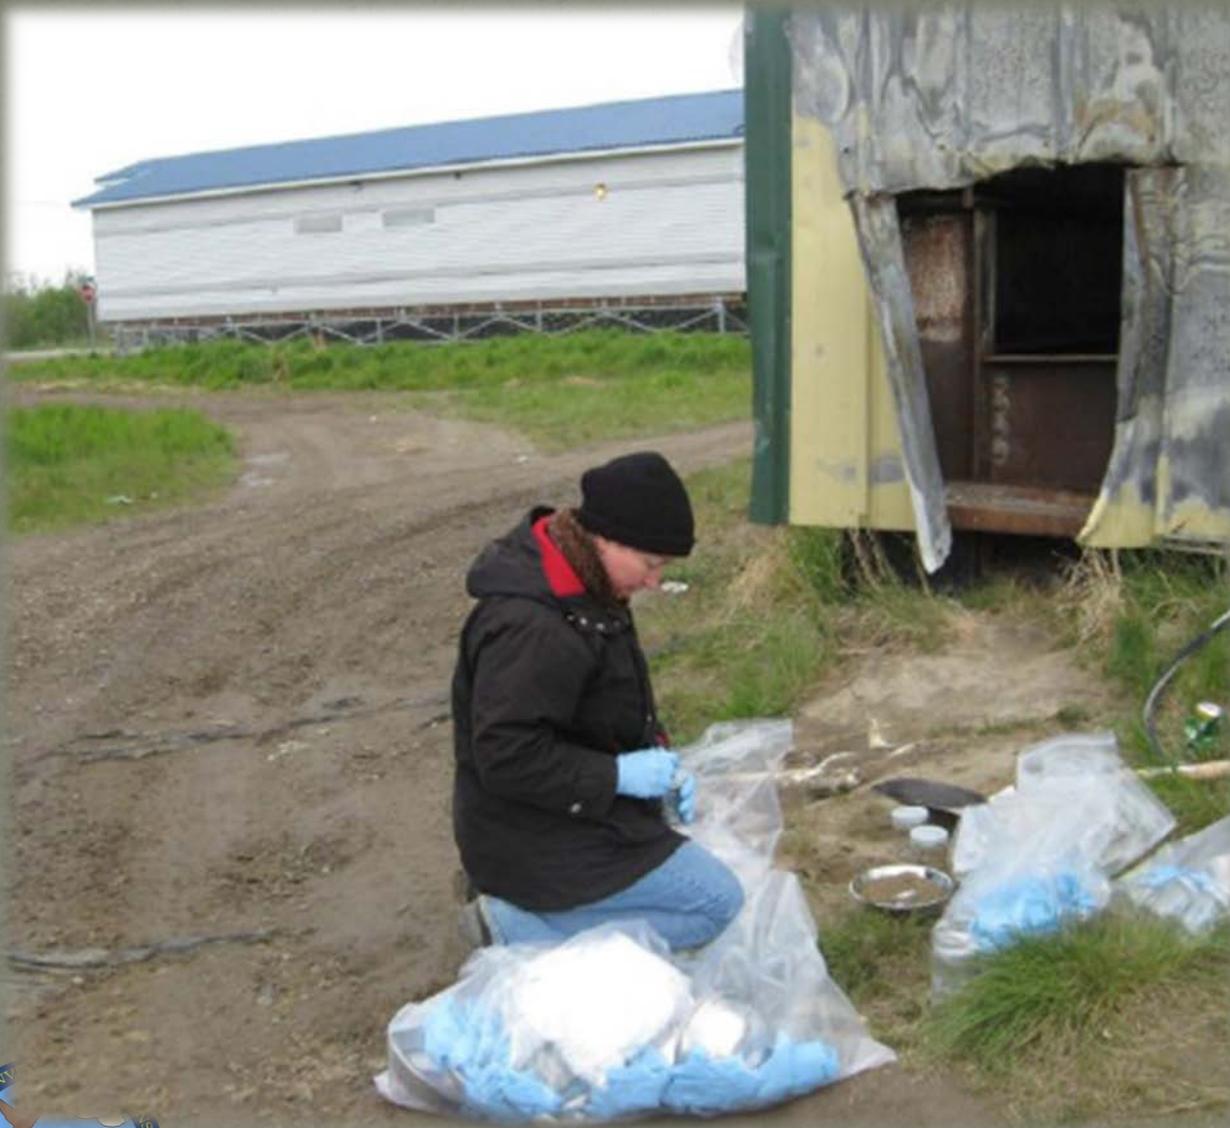
TBA - 2010

Samples are collected in accordance with laboratory procedures

Protective gloves are always worn

Laboratory materials and sampling supplies bagged

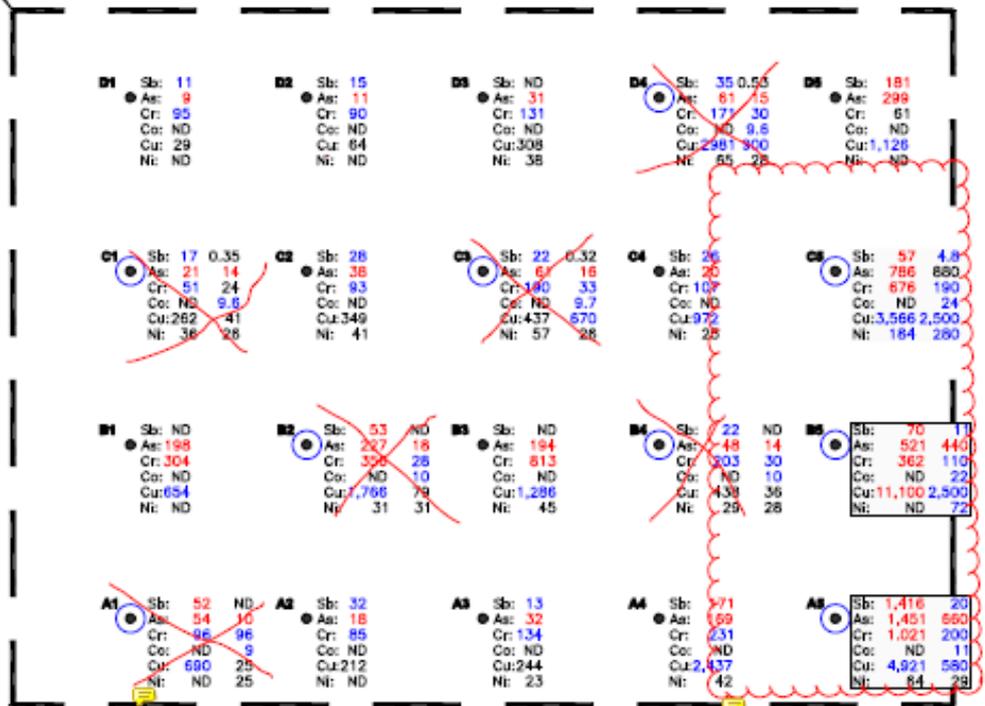
FORMER BUILDING FOOTPRINT

Unforeseen metals contamination

Building footprint outline

Contamination remained along one side

Attributed to wood preservative

- Return to site and 'supersack' the area with elevated concentrations
- Sample this material for RCRA hazardous waste determination
- Ship out the material that fails Haz-Waste testing
- Scrape the site clean

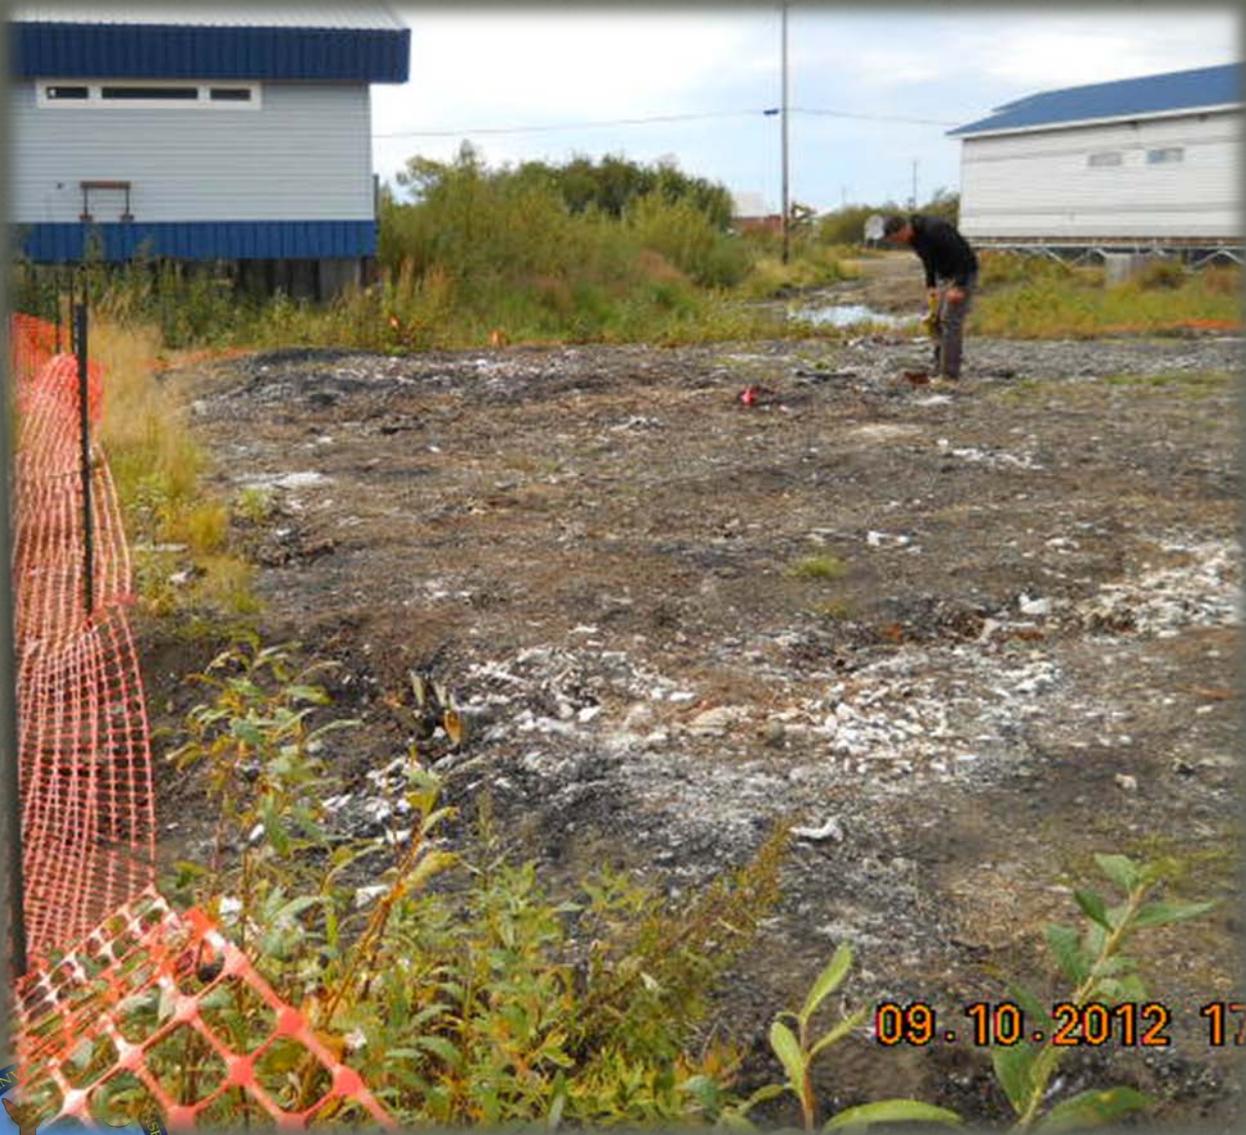
September metals cleanup

Returning to the site

Remnant debris
across the footprint

Fencing down

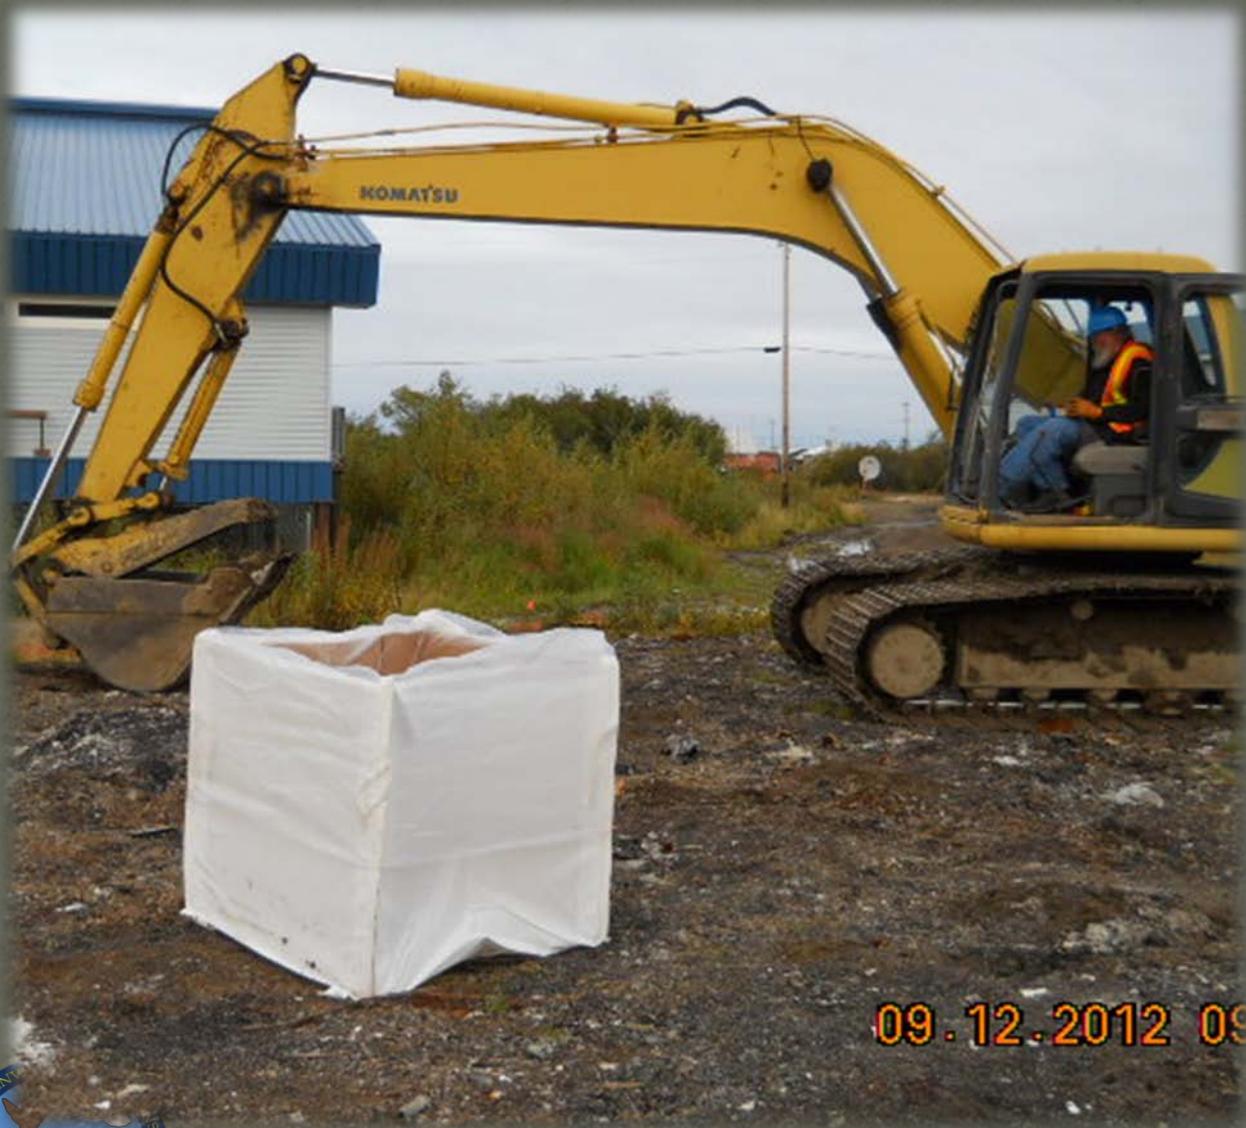
September metals cleanup

Filling supersacks with available equipment

Scraping down 6 – 12 inches across the area of footprint

Yes, it does look a little overkill...

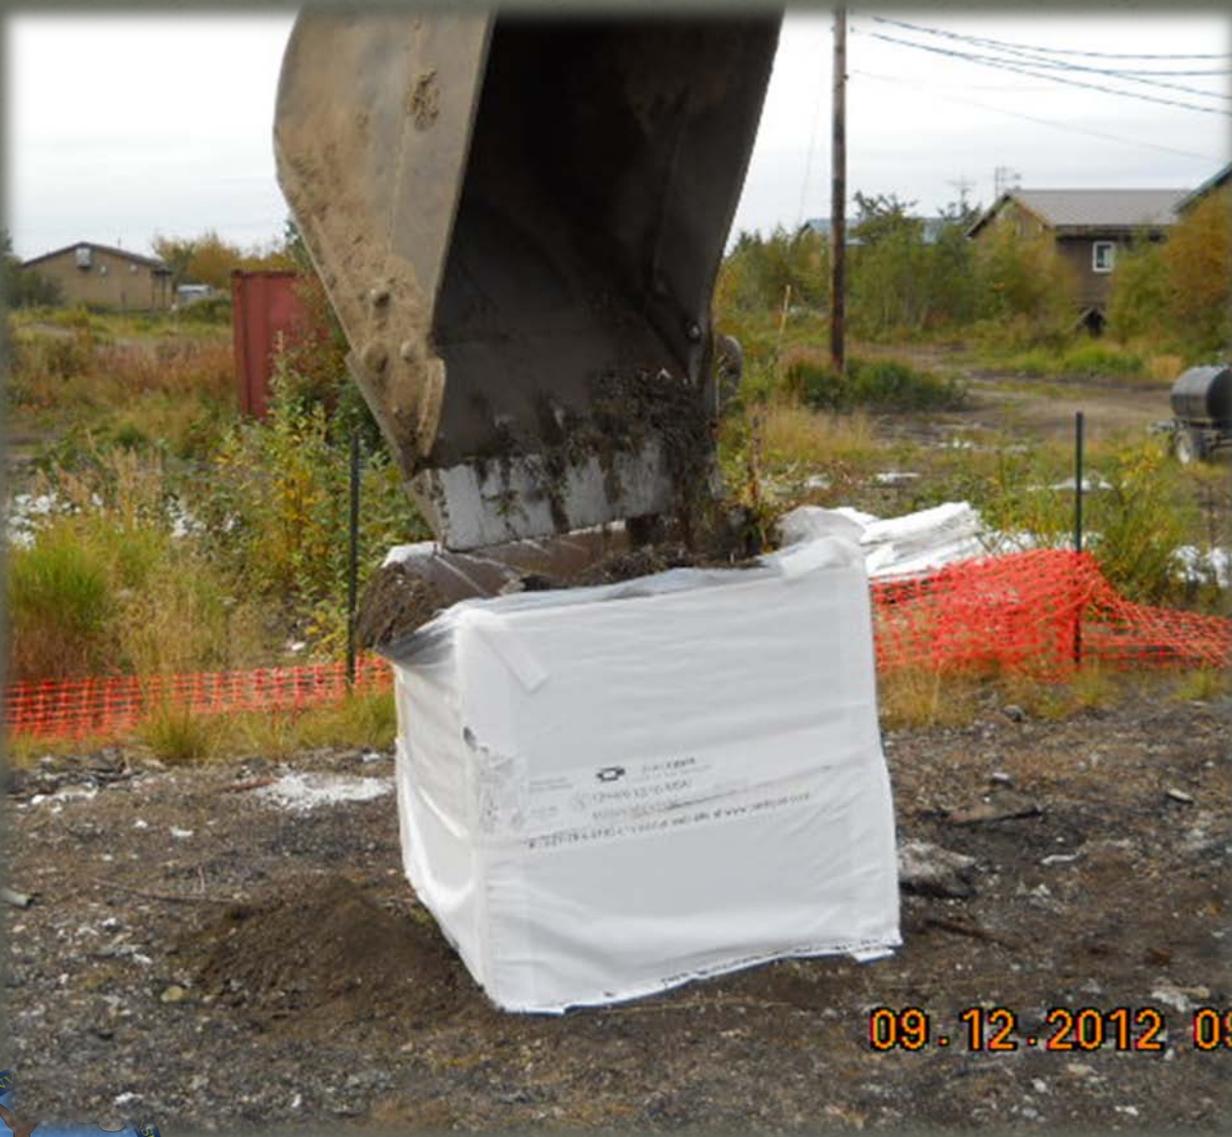
September metals cleanup

Strategic placement
of soil into the bag

Each bag holds about
1 yard

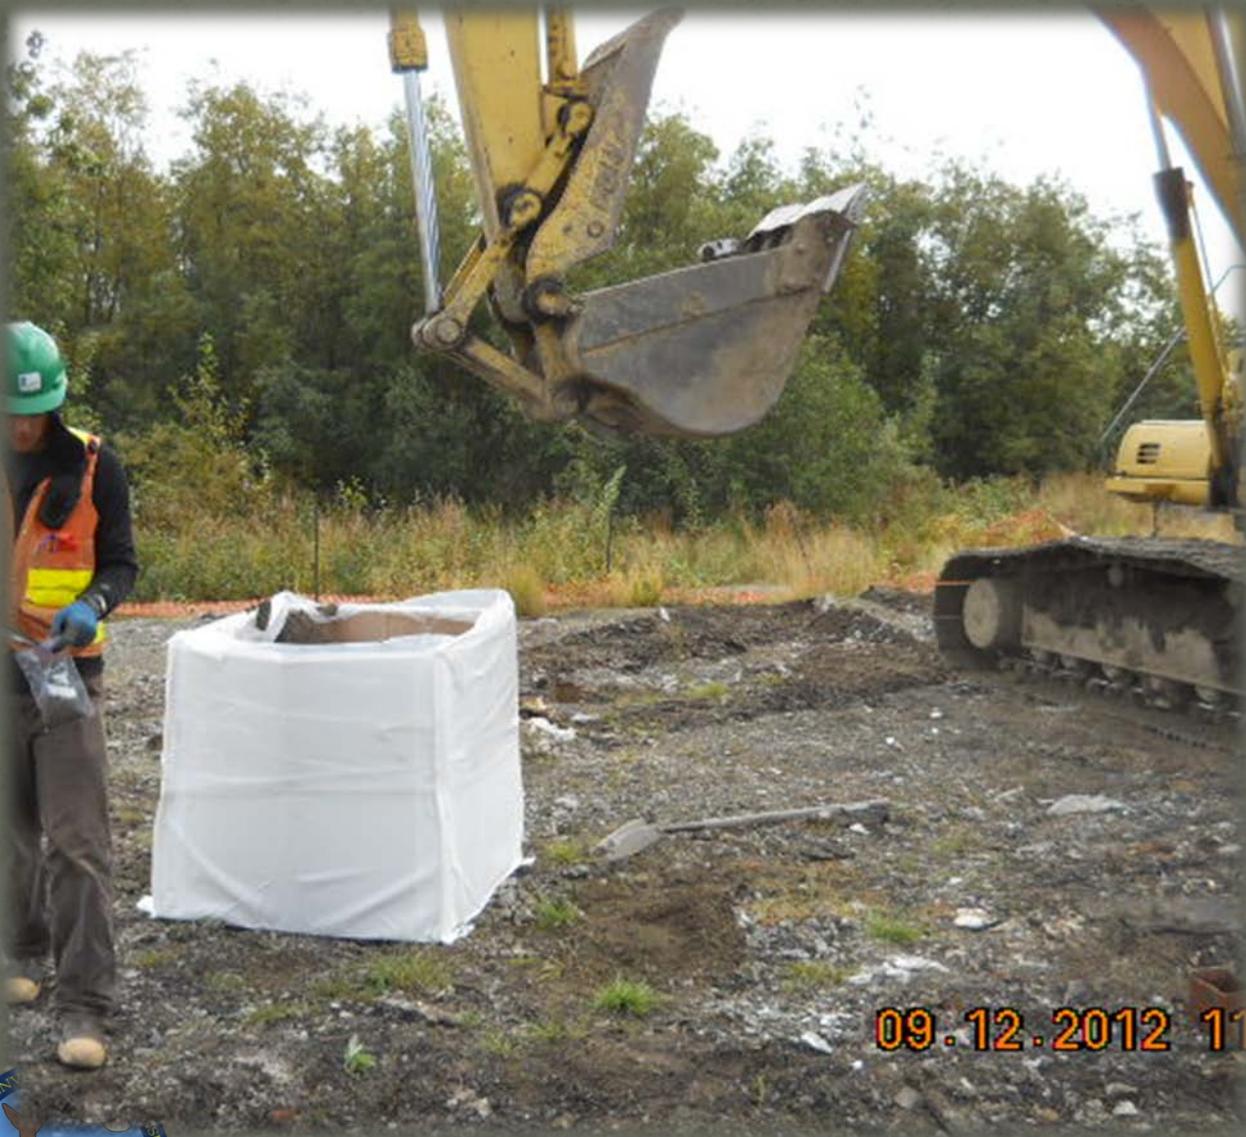
September metals cleanup

Collecting samples from each sack

The process of putting the soil into the bags 'mixed' the samples prior to collection of sample

Samples analyzed for 'TCLP' or hazardous waste characterization for metals

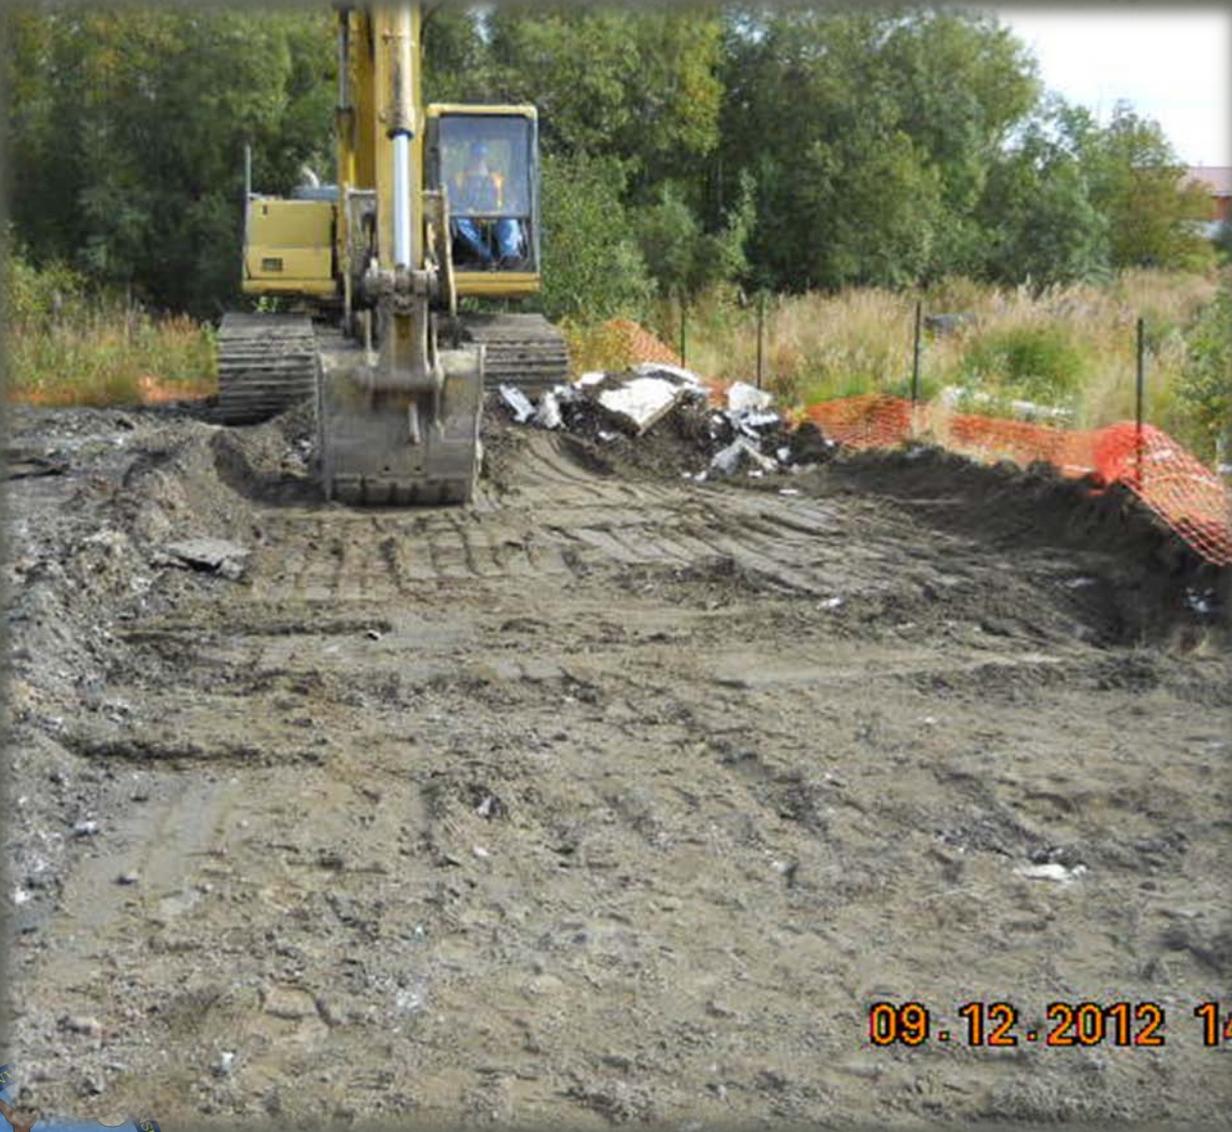
September metals cleanup

The area that was scraped and bagged

It was believed that the wooden ramp in this area was preserved with chromated copper arsenate

The metals went into the soil when burned

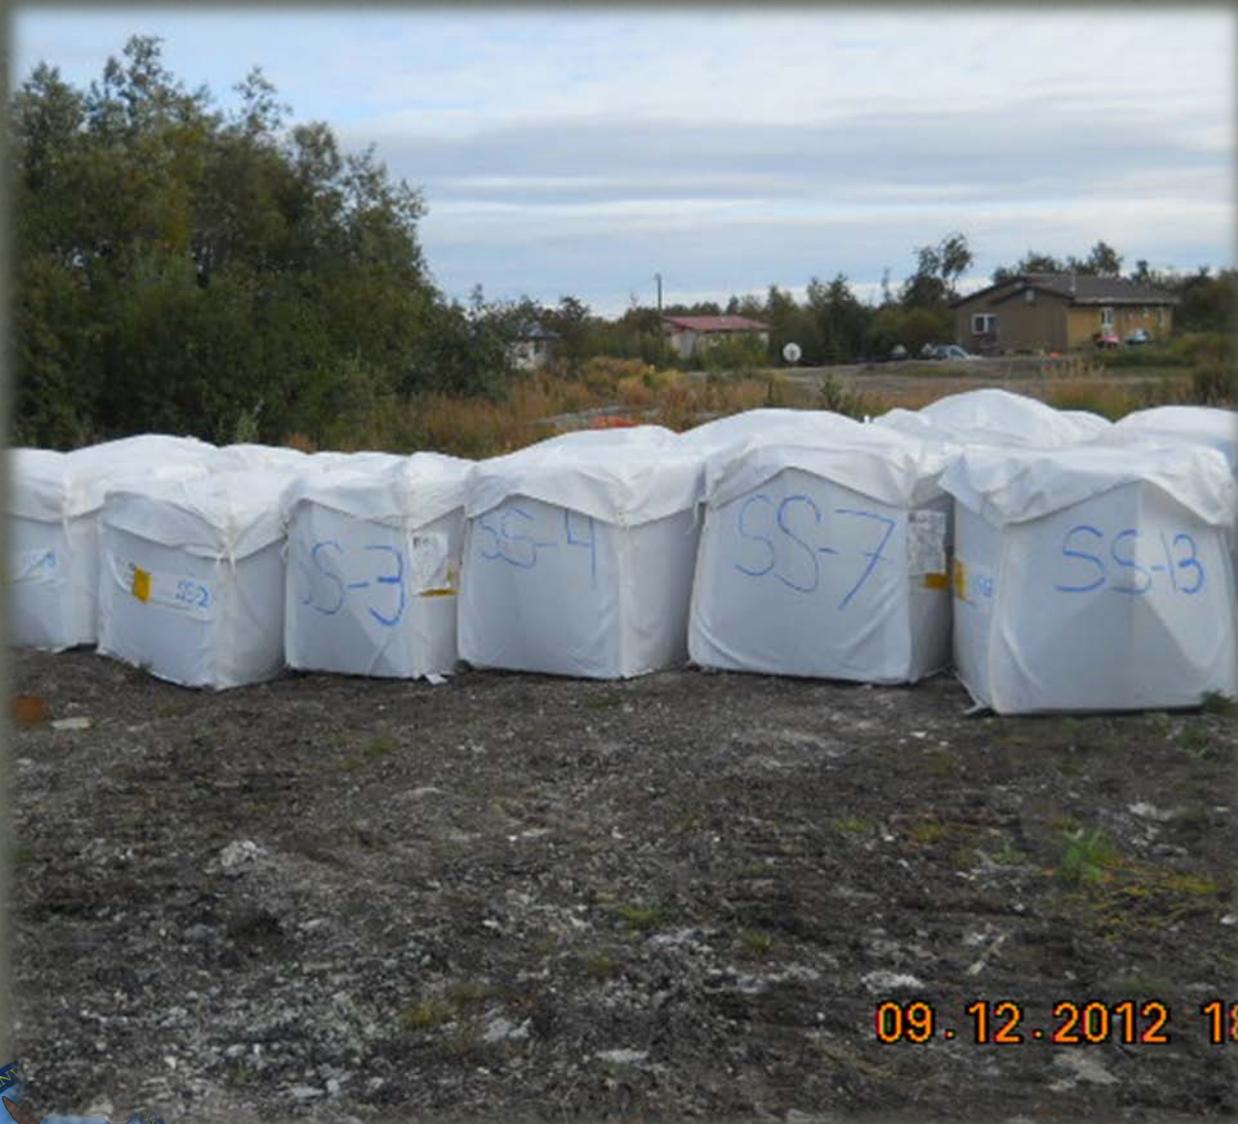
September metals cleanup

Thirteen bags of soil were removed from the site, and sampled individually

Left onsite since it is against regulation to simply remove hazardous waste from the site

Fate of soil pending results

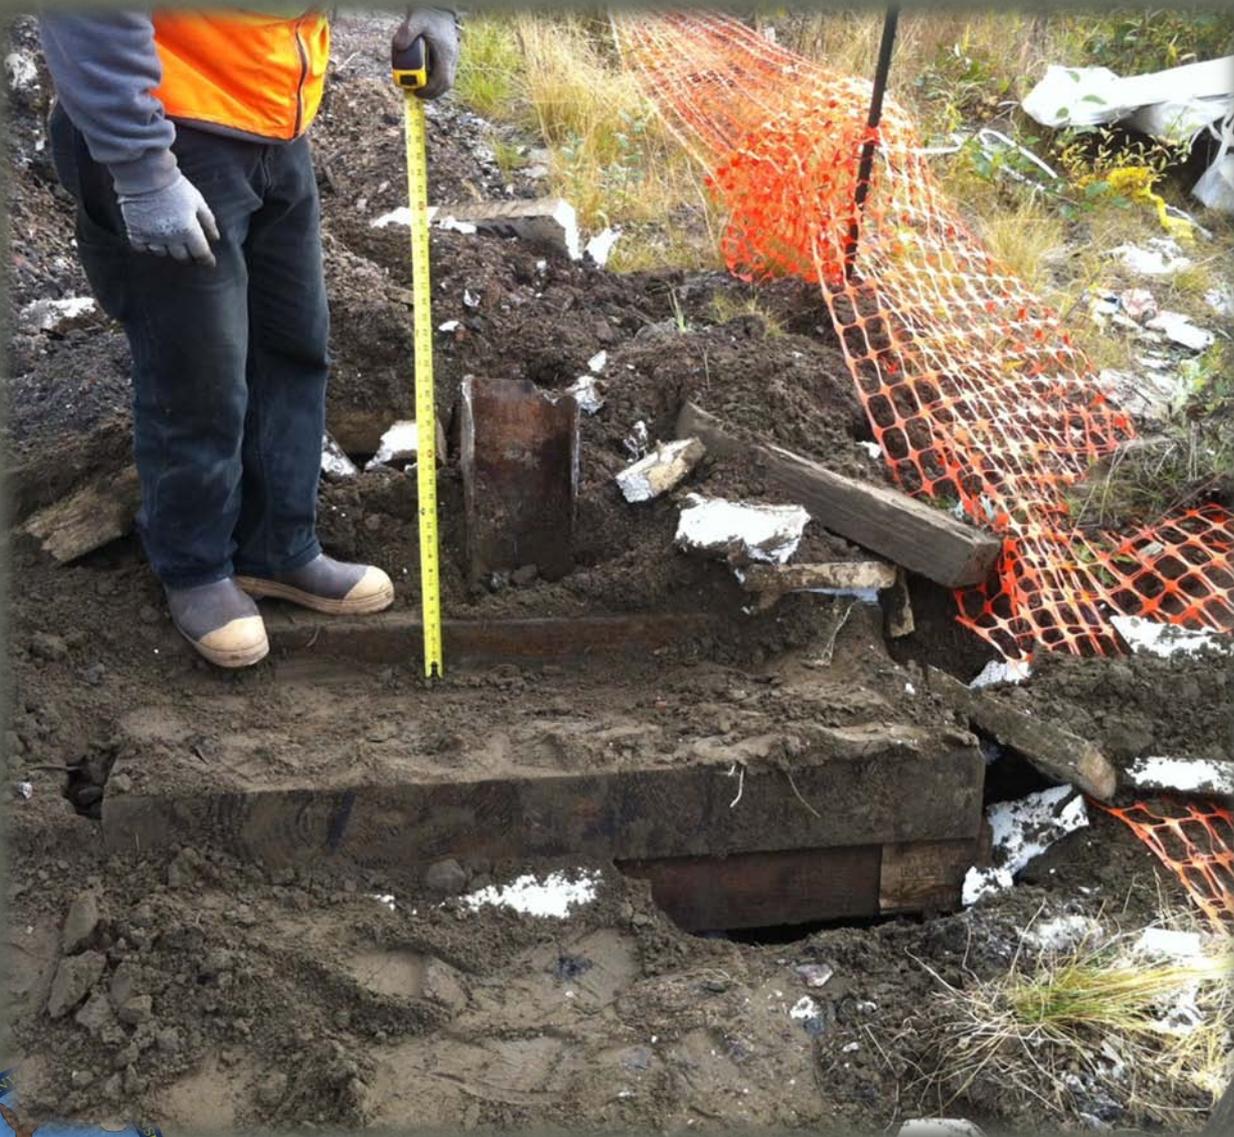
September metals cleanup

Piling materials were another issue to contend with

Sixteen pilings were situated across site and the stub above grade impeded access

Were going to remove them, but determined they may be reused

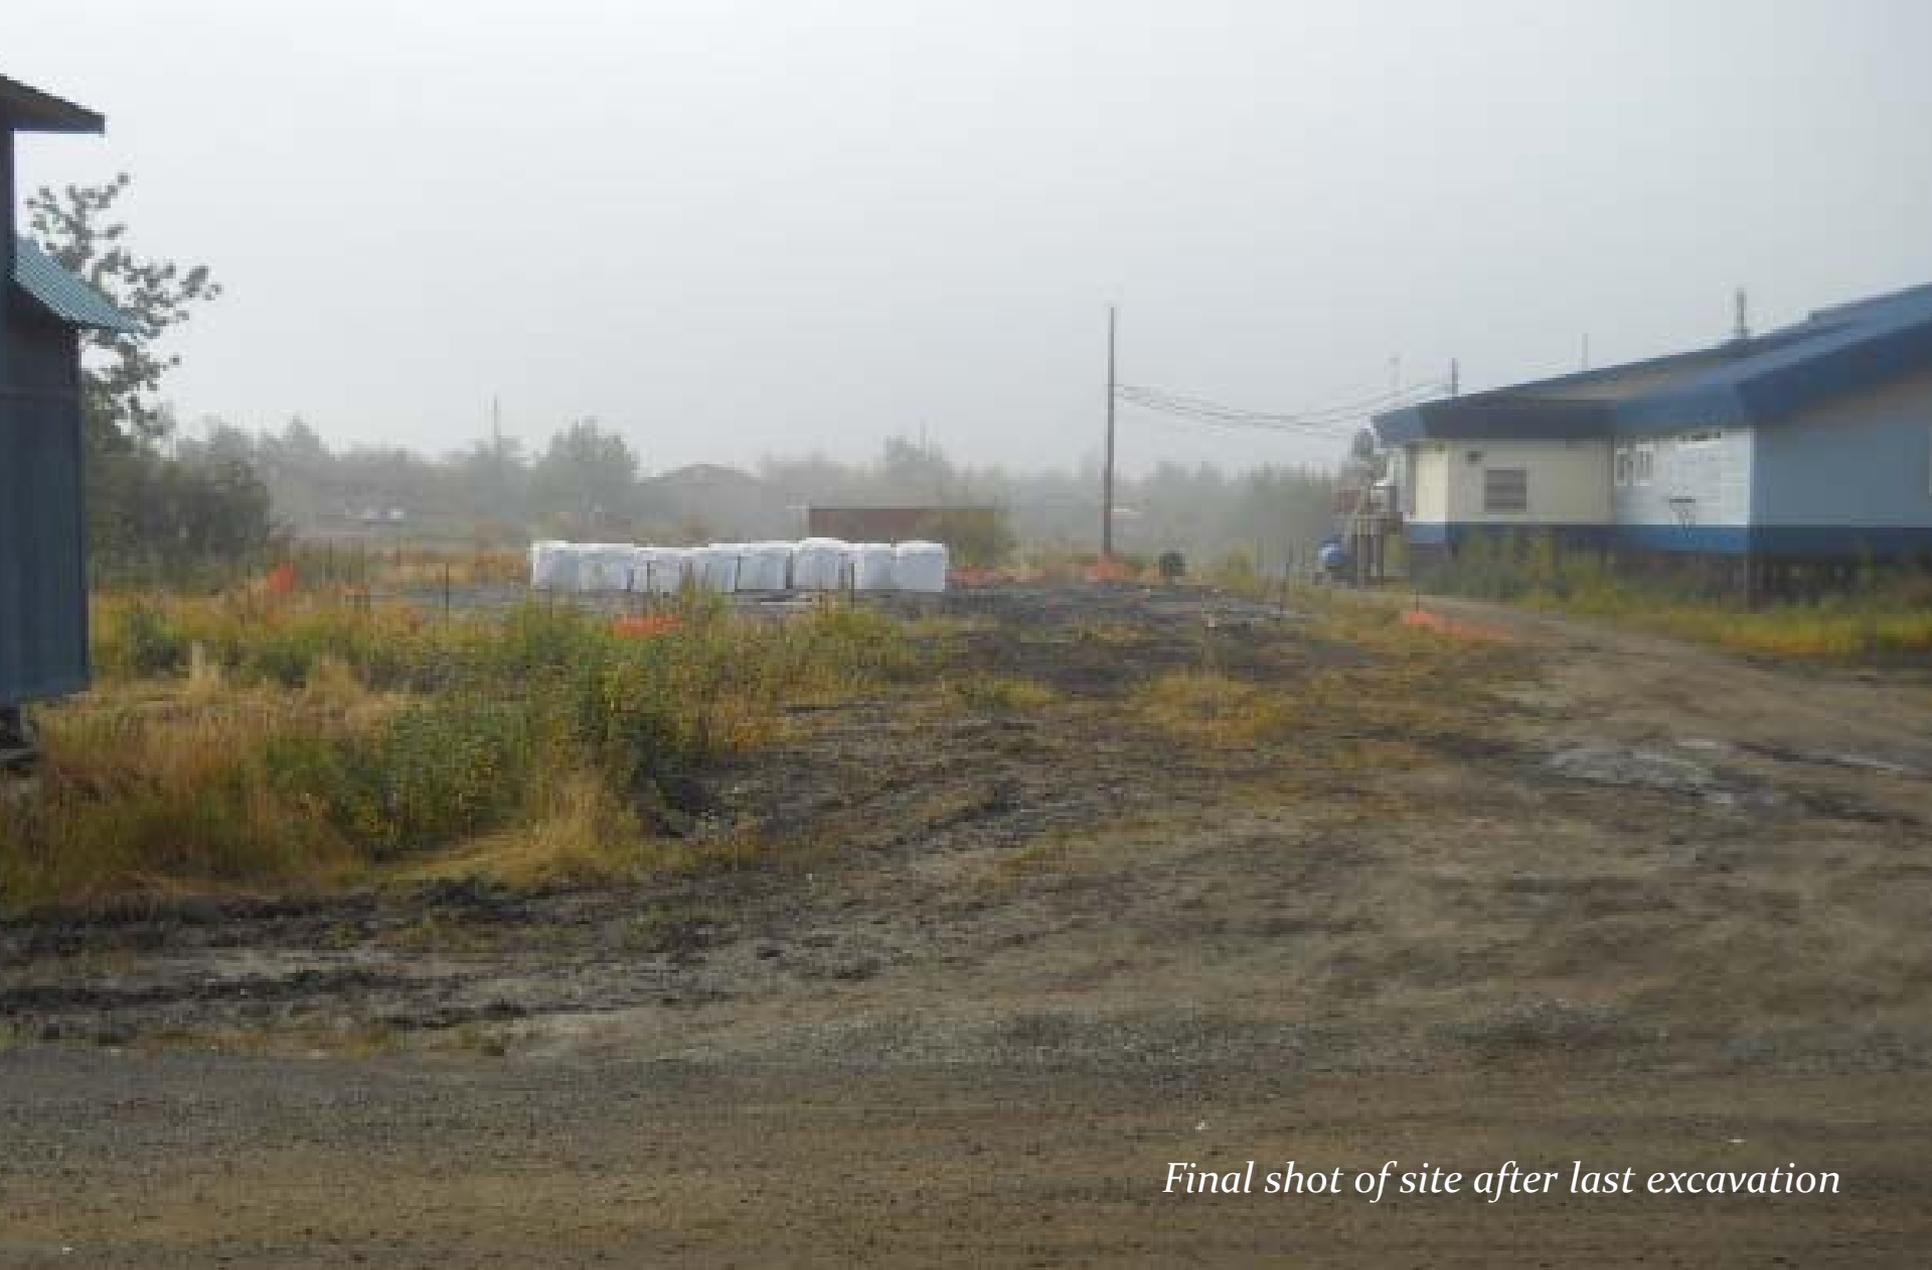
Final shot of site after last excavation
