Hughes Brownfield Case Study

*A State and Tribal Response Program Clean Up of the
Former Community Tank Farm Generator Footprints in
Hughes, Alaska*

Alaska State and Tribal Response Program Workshop

December 11, 2012

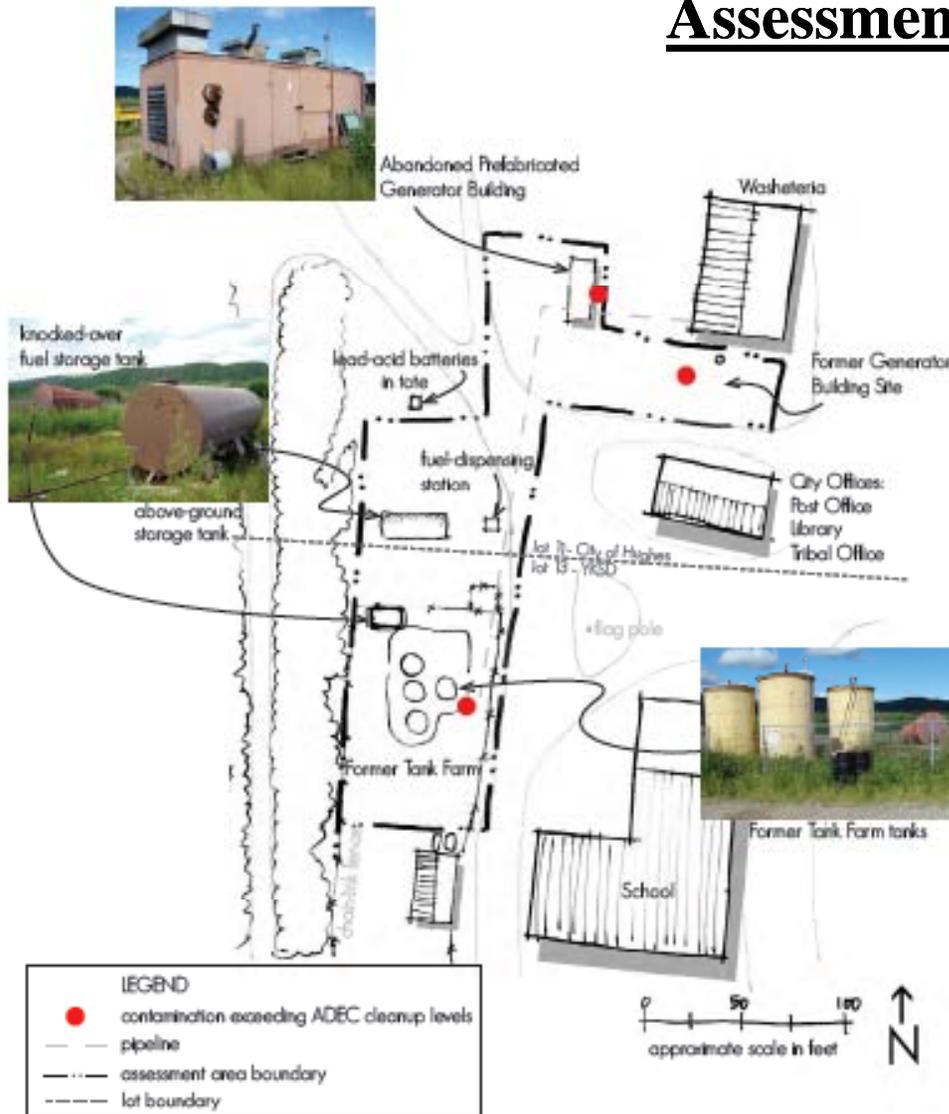
Figure 2: Site Map and Locations of Contamination

- Abandoned Generator Building
- Location of Former Generator Building
 - Location of Former Fuel Dispenser Island
- Buried Piping Between Former School Tank Farm and Abandoned Generator Building
 - Former School Tank Farm

1. The Abandoned Generator building due to the installation of the new water tank scheduled for 2012;
2. The footprint of the Former Generator Building due to its proximity to the community drinking water well;
3. The former fuel dispensing island; and
4. The above-ground portion of pipeline connecting the former generator buildings to the school tank farm.

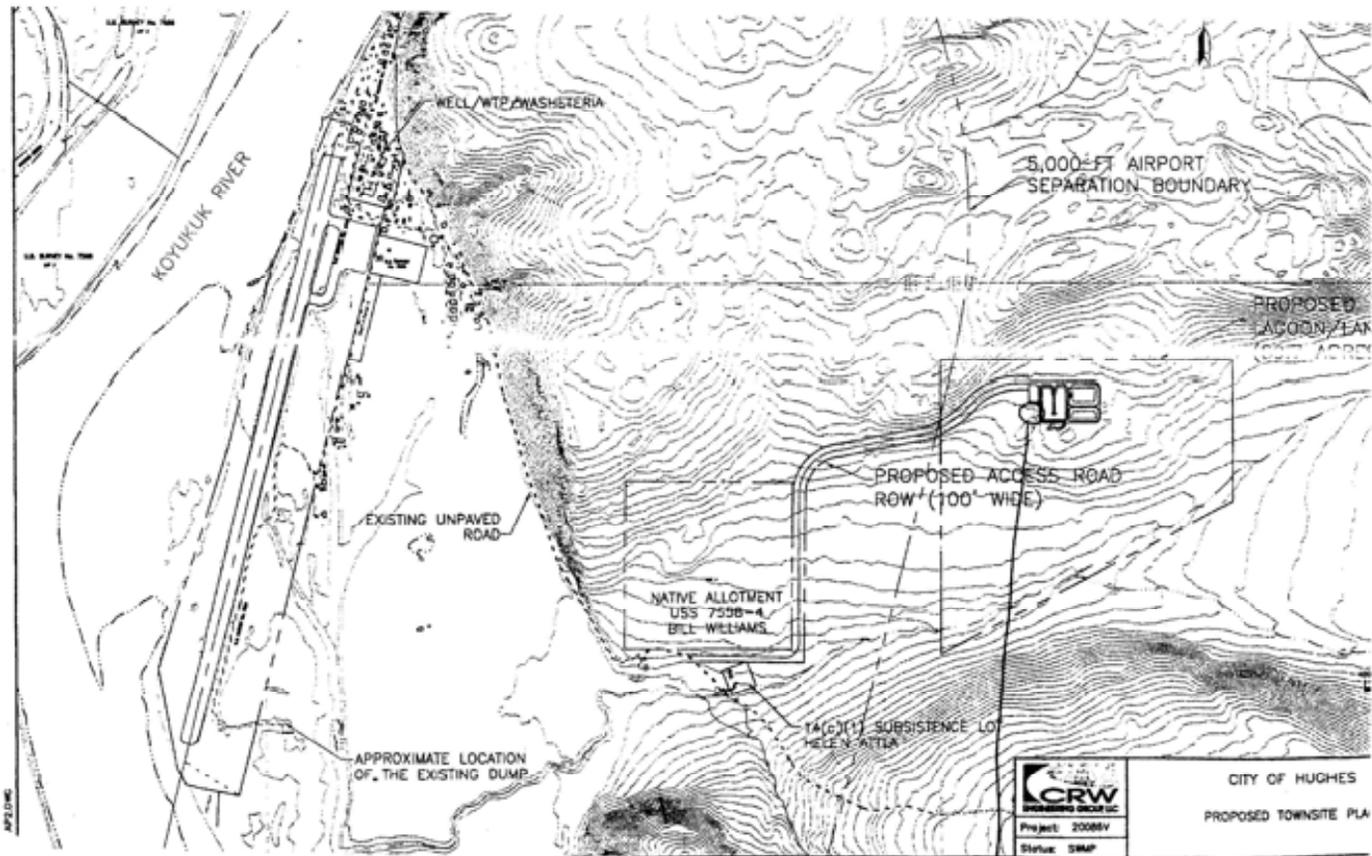
Site Surveying – Containment Cell

Circled spot for gravel storage
8.1.12.

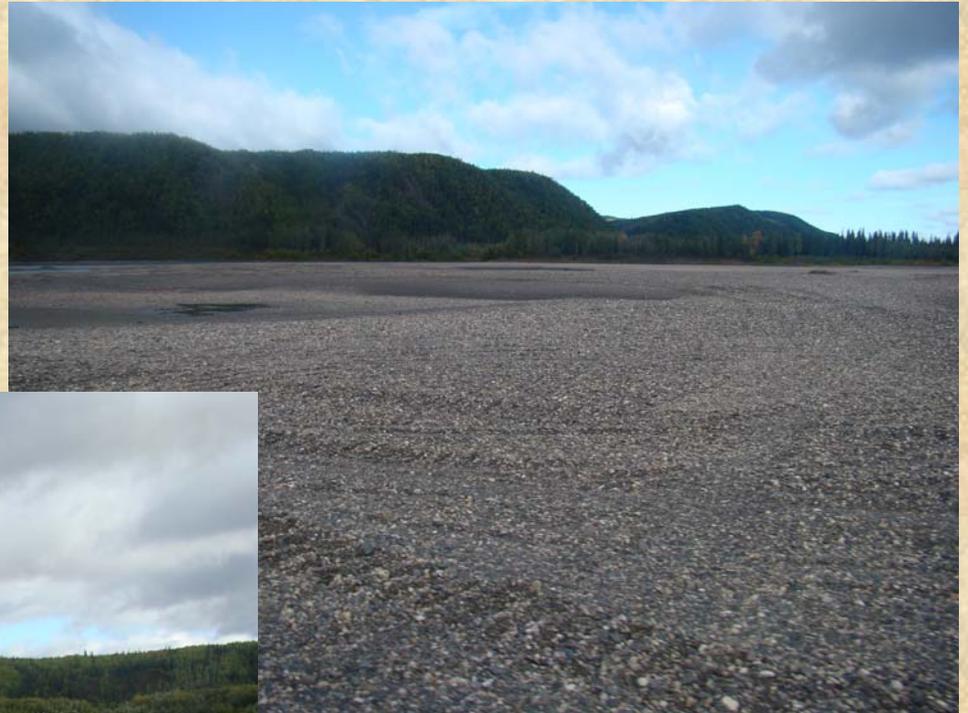
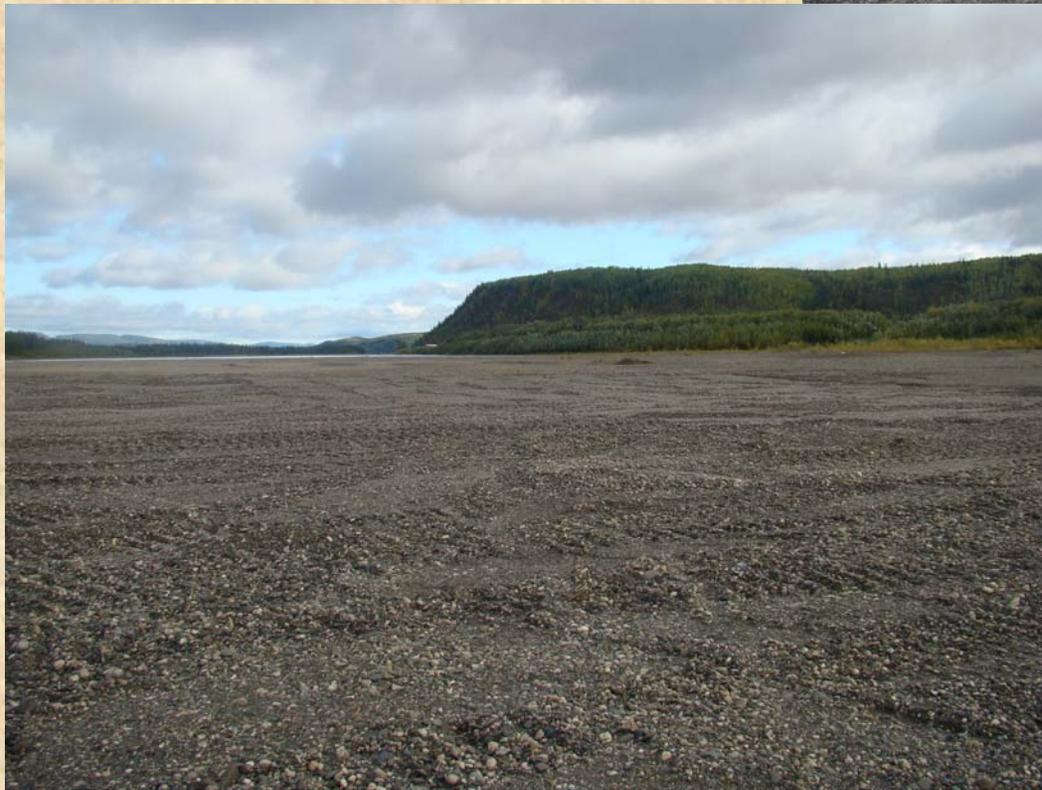
Site Surveying – Fill Material

**Hughes Village Council has a material sale contract with Department of Natural Resources
Approximately 300 cubic yards were removed for stockpiling before potential flooding**

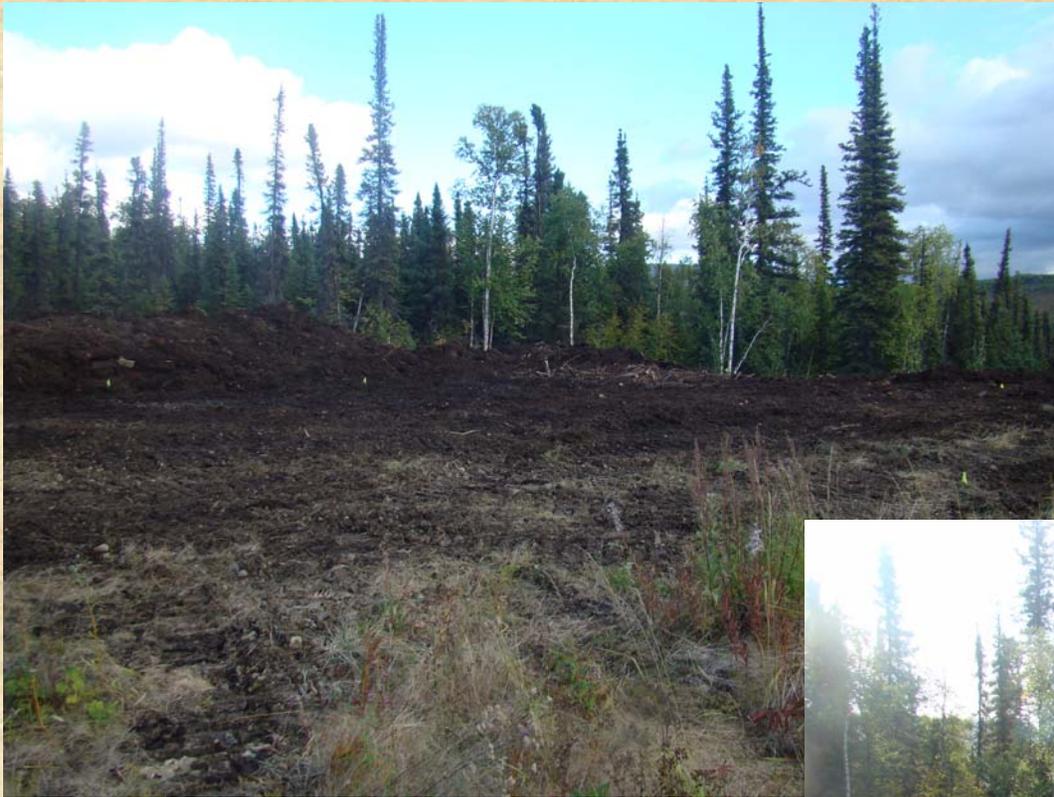
Containment Cell Construction

**Dimensions are approx:
100ft X 50ft = 5,000 sq. ft.**

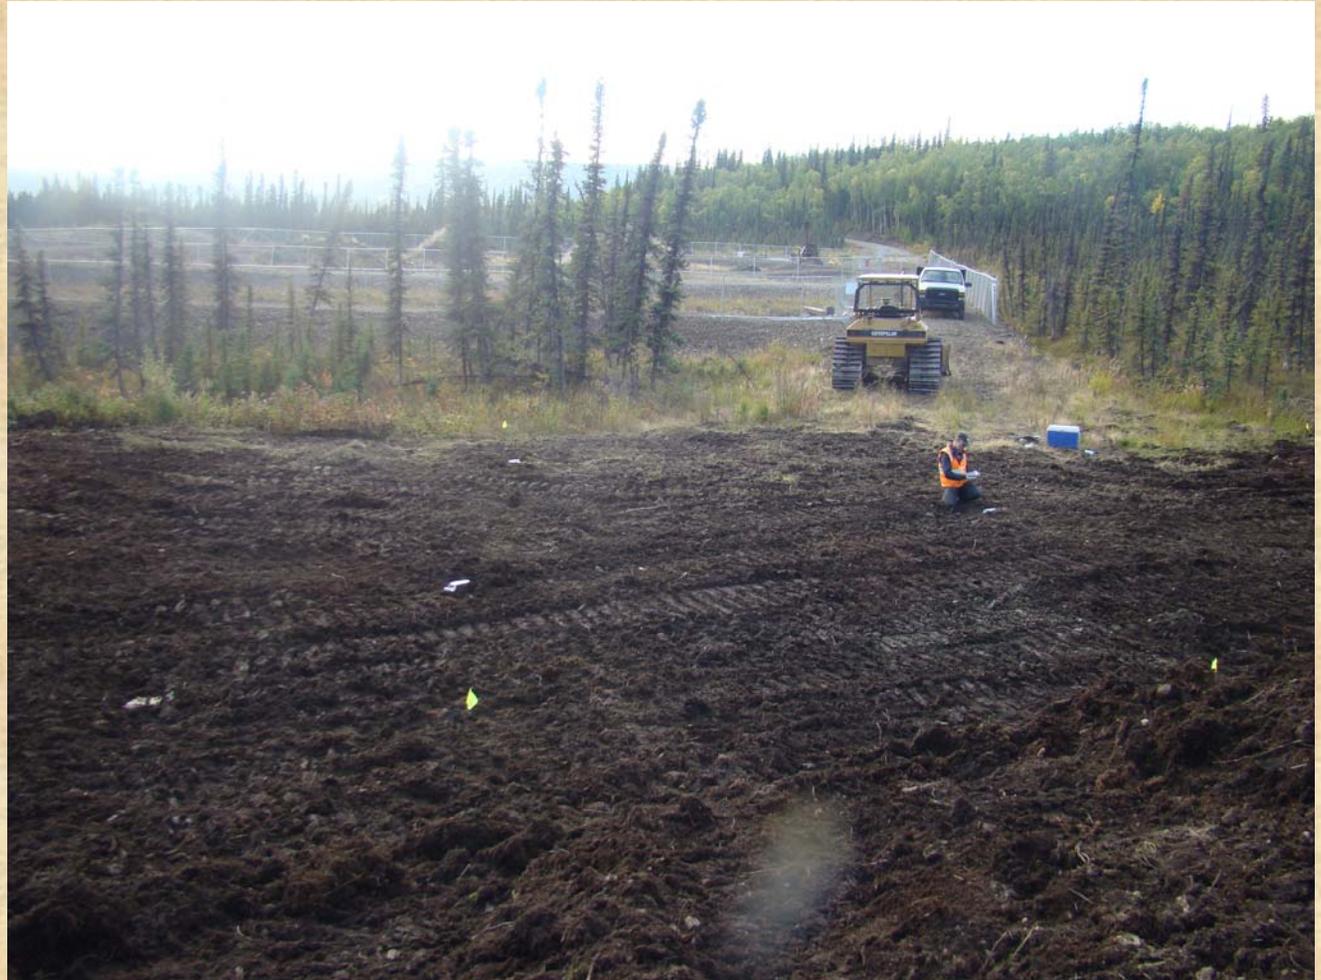
Sampling Prior to Stockpiling Soil

**10 random screening
samples collected
within cell and to 1 ft.
deep**

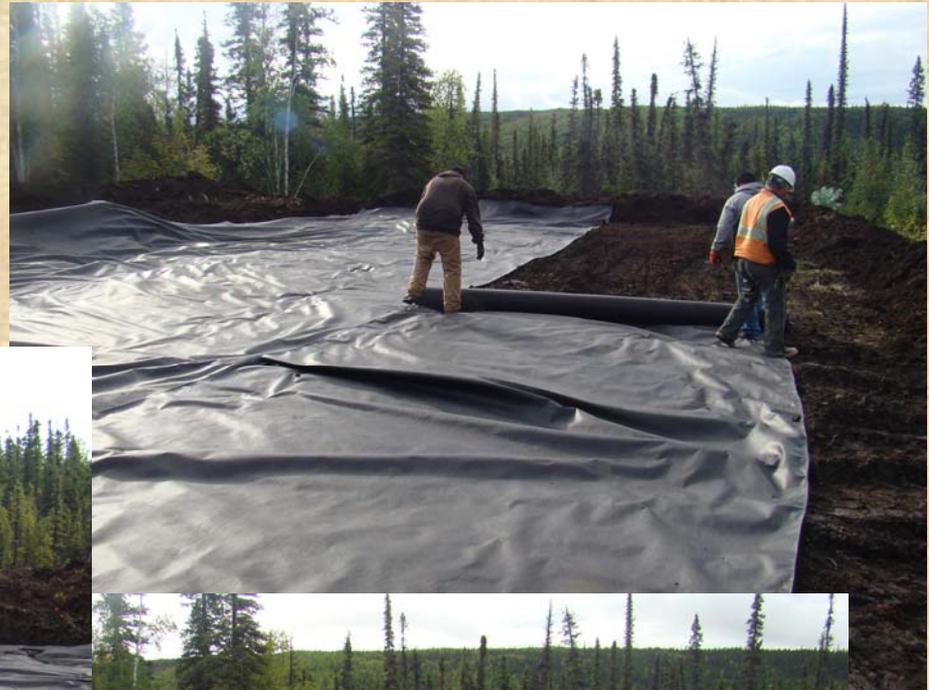
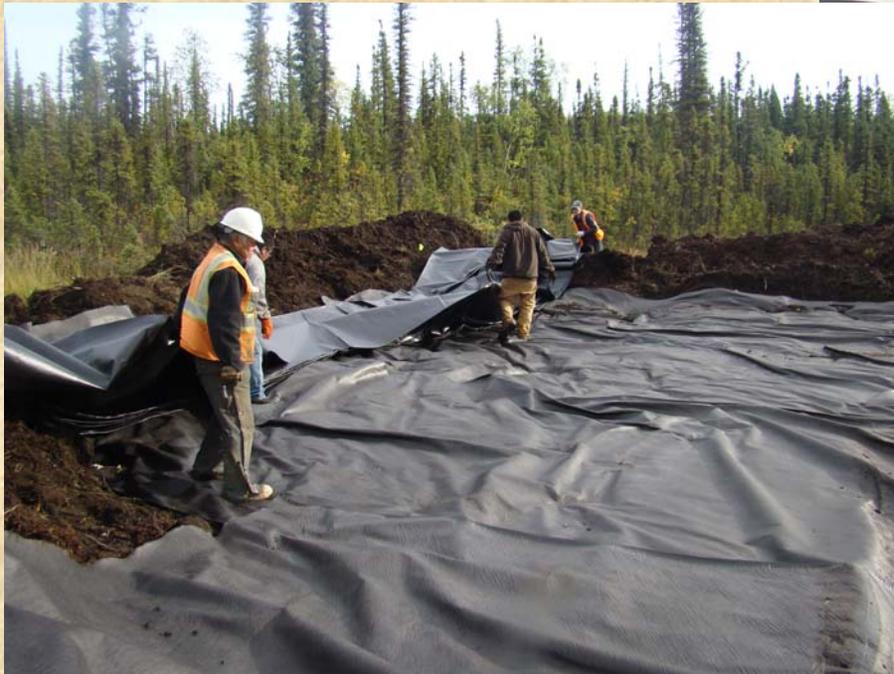
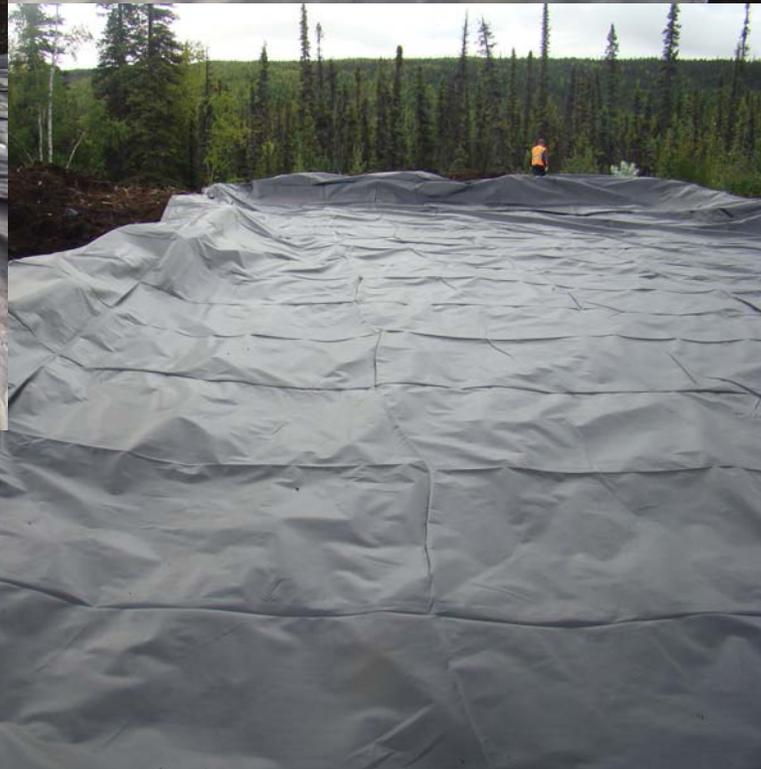
First, protective non-woven geotextile fabric

Then, 20-mil thick petroleum resistant liner

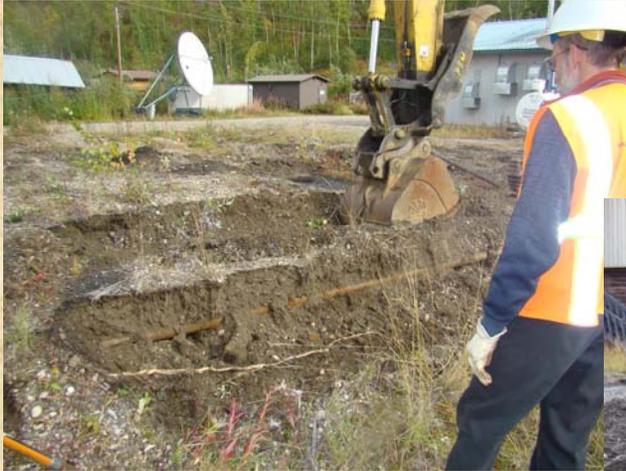
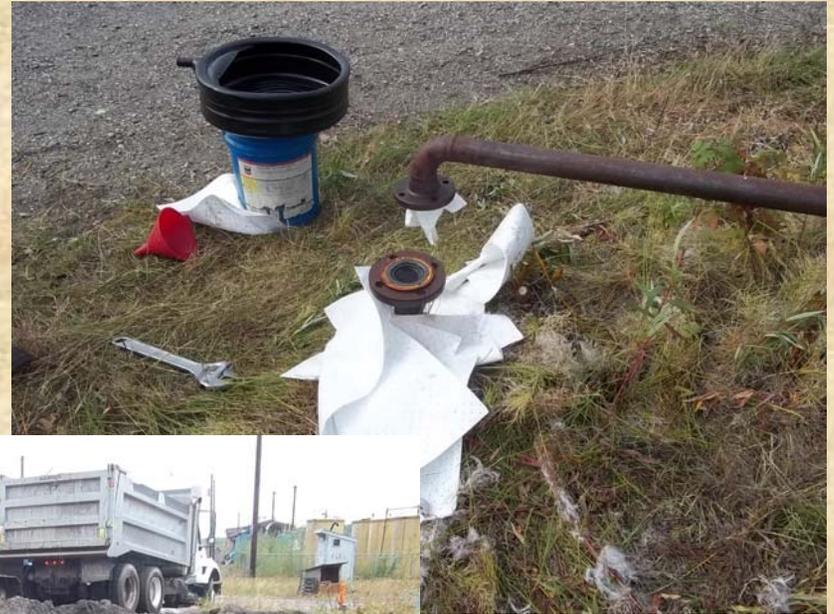
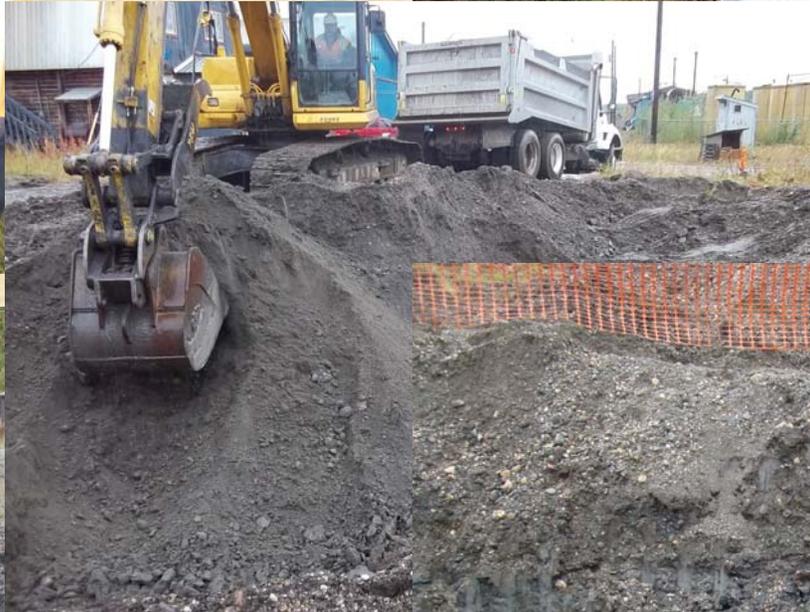
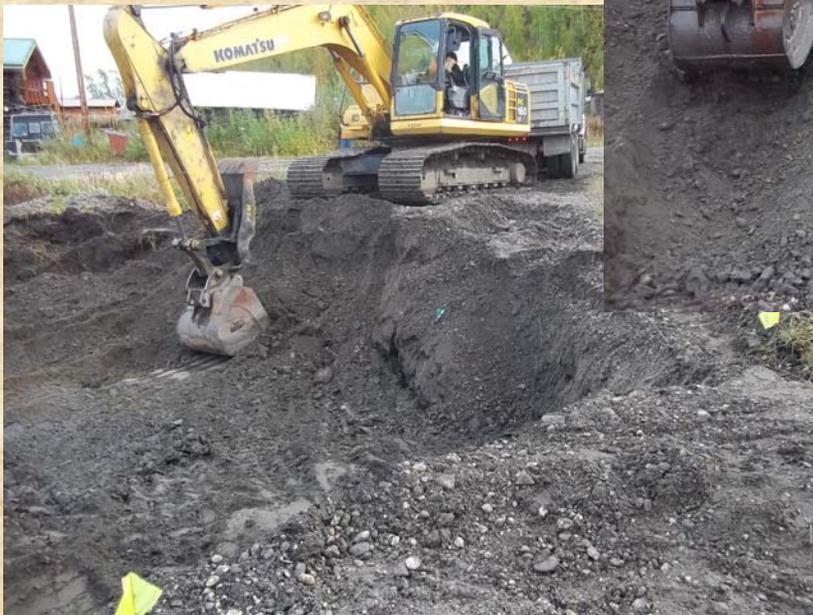
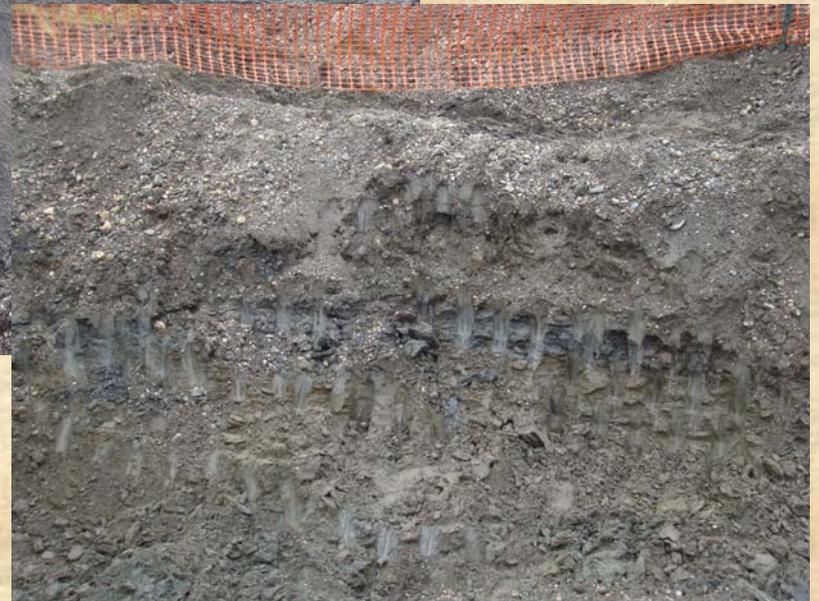
Excavation 1: Abandoned Generator Building

Approximately 270 cubic yards removed

Approximately 340 cubic yards of potentially contaminated soils were removed from the center of the community and placed in a landfarming cell on the east side of the landfill

Landfarm soil thickness is estimated at 3.5-4 ft. Hughes is recommended to till the landfarm soil at least twice every summer to enhance degradation and to also cover the soil with 6-mil polyethylene sheeting in winter – reduces amount of water from entering cell and increases solar heating

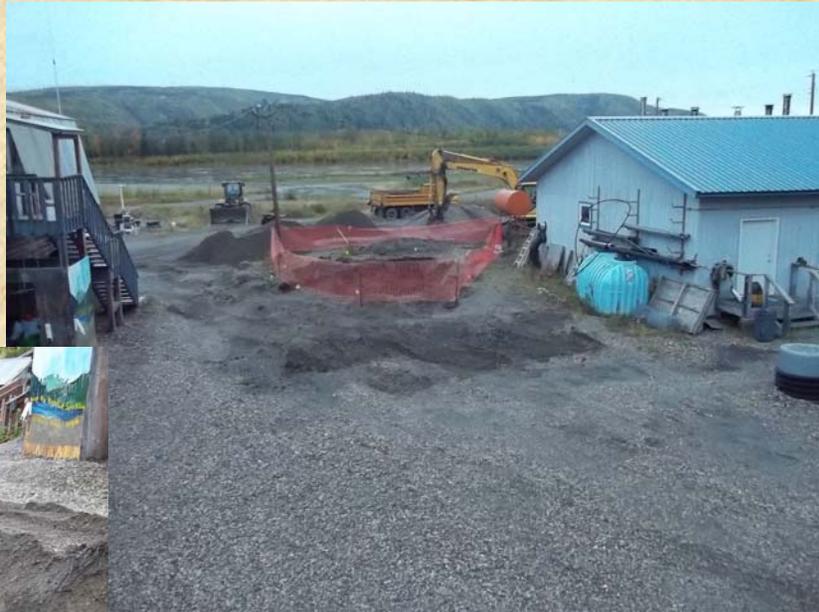
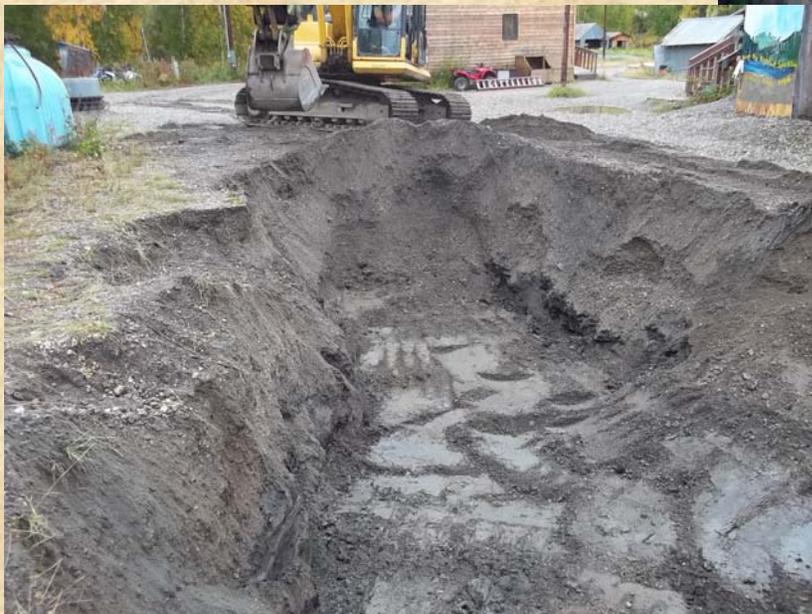
Excavation 2: Former Generator Footprint

Approximately 70 cubic yards removed
