## UGASHIK

Database Name: Former APA Cannery (Ugashik)

Location: East side of Ugashik River, Ugashik

Summary Updated: March 2012

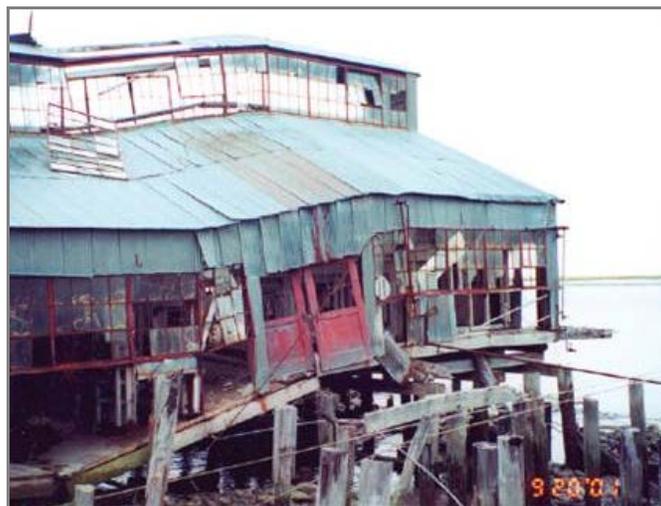
View of the collapsing main cannery building. Looking southwest.

Abandoned for more than 50 years, many of the cannery buildings are in disrepair. The north cannery building is now being used for vehicle and equipment storage. The main cannery building, where fish processing operations took place, is collapsing and contains

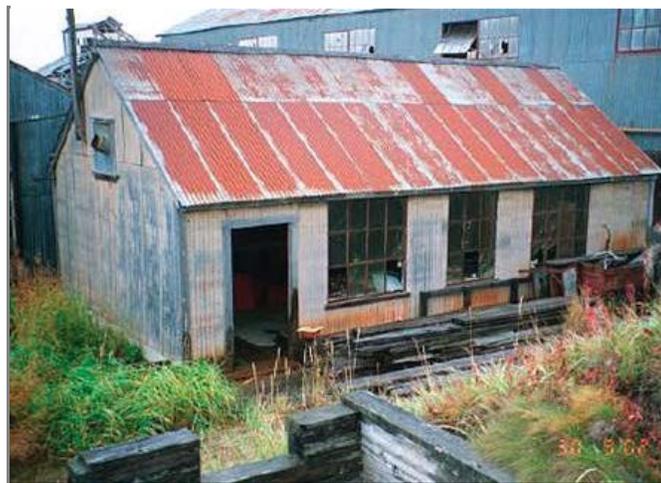
View of the powerhouse annex. Looking northwest.

suspected asbestos-containing materials that may become airborne and transported through the building's broken or missing windows and doors. The areas around the powerhouse and boiler room also contain suspected asbestos-containing material, partially full ASTs in poor condition, transformers, and stained soils.

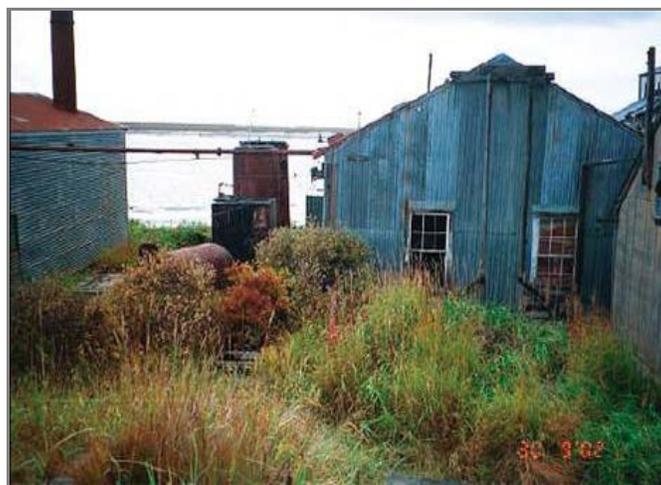
View of the powerhouse and alley. Looking west.
